GM0001-L / 3C Grinding Mill #1

Synopsis

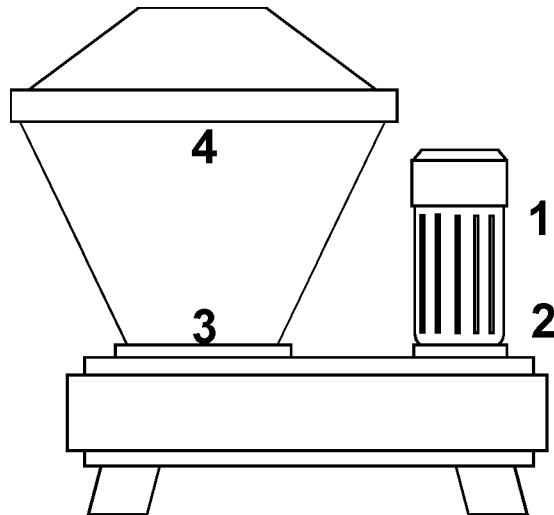
The asset is a vertically mounted, belt driven grinding mill, as shown in Figure 1. The drive spindle has three (3) bearings: two (2) cylindrical roller bearings and one (1) ball bearing. The mill is being belt driven by a 100 hp, two-pole motor. The mill normally operates at 3,150 rpm.

1. Outboard Motor Bearing
2. Inboard Motor Bearing
3. Inboard Mill Bearing*
4. Outboard Mill Bearing

* Bearing that was failing.

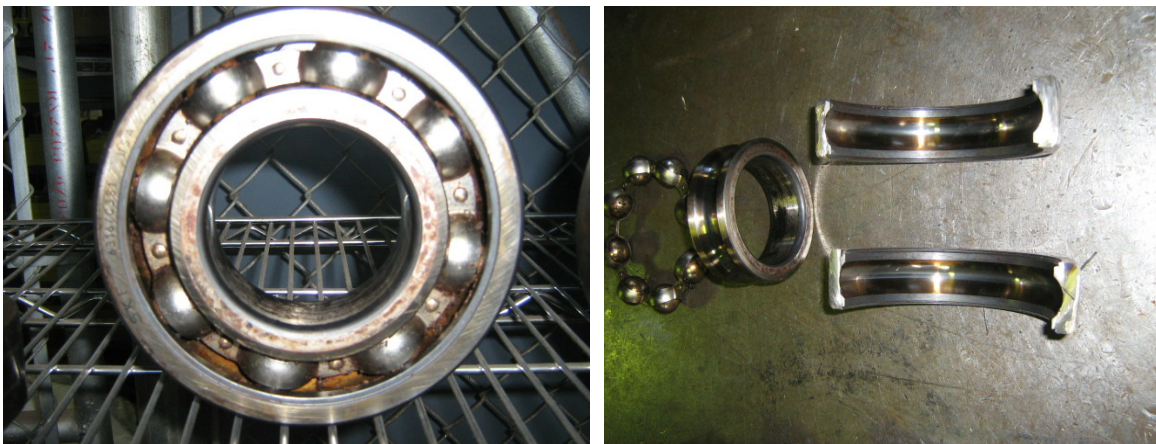
In 2007, the vibration spectra began displaying excessive looseness. A work order was submitted by the vibration analyst, and the bearing assembly was rebuilt and reinstalled by on-site mechanics. (See Figure 2.)

Figure 2: These are photos of the SKF 6313 C3 ball bearing that was replaced during the 2007 rebuild.

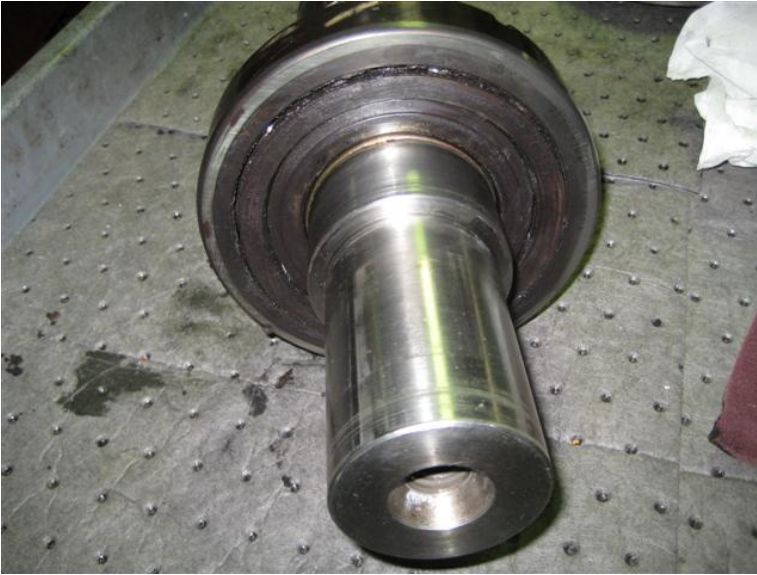
In September 2009, the vibration data was again showing bearing defects. At this time, the old bearing housing, shaft, bearings, and seals were sent to a local precision mechanical shop for assembly. The on-site mechanics performed the replacement of the bearing assembly, rotor, sheaves, belts, and motor. (See Figures 3 and 4.)

Figure 3: Photo of ball bearing that was removed during the 12/2009 rebuild.

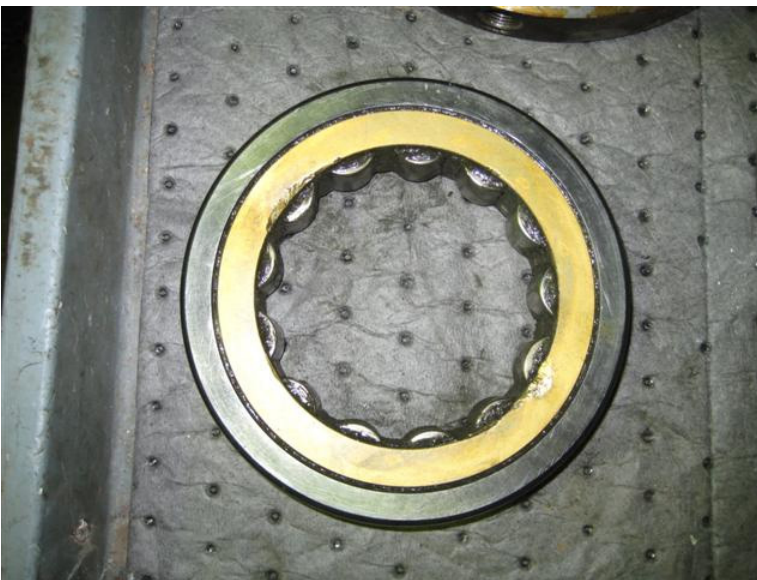
Figure 4: Photo of cylindrical roller bearing that was removed during the 12/2009 rebuild.

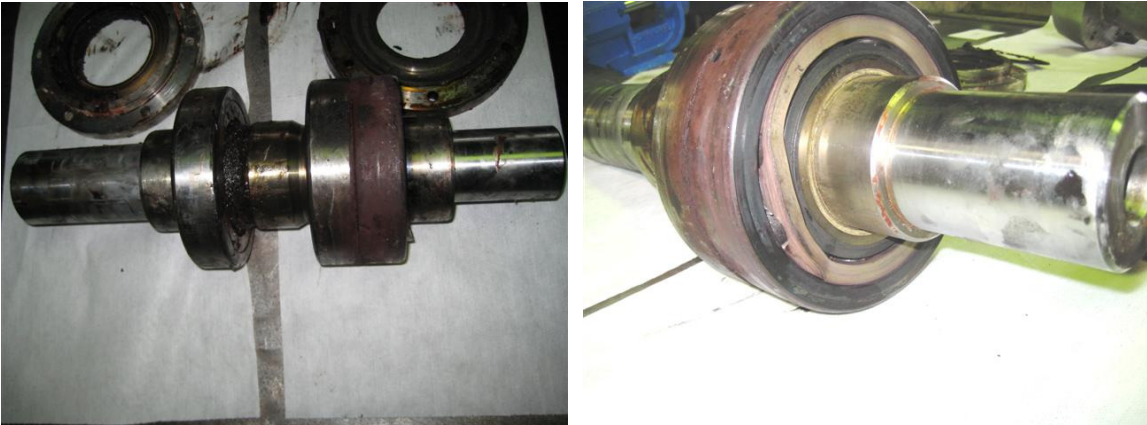
In February 2010, the bearings failed again, this time with very little notice. A new bearing assembly was purchased from the manufacturer at this time. This assembly was again installed by the on-site mechanics. (See Figure 5.)

Figure 5: Photos of bearing/shaft assembly that was removed in 2/2010.

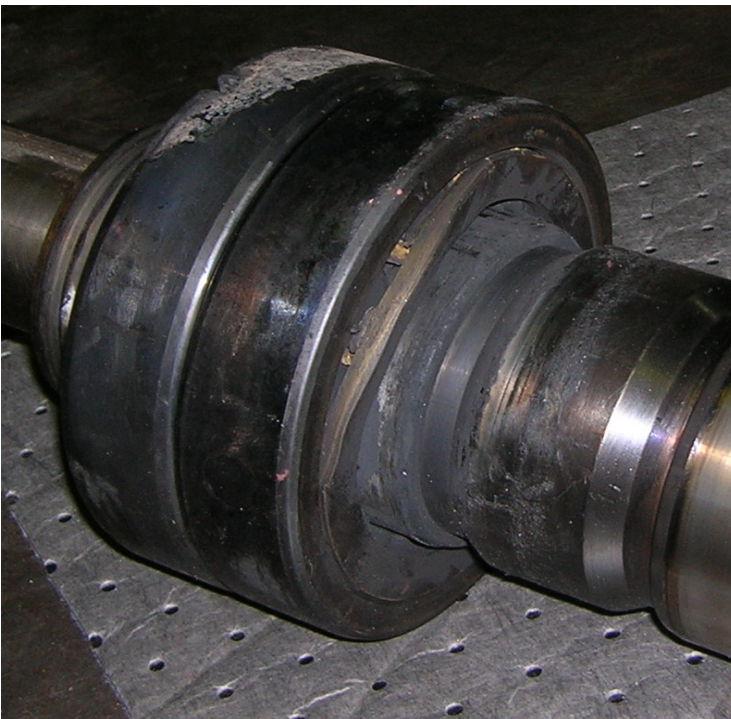
In November 2010, the bearings failed yet again. (See Figure 6.)

Note in the photographs in the Supporting Data section that all of the ball bearings (with the exception of the first one) failed in the axial plane.

Figure 6: Photo of ball bearing removed during the 11/2010 failure.

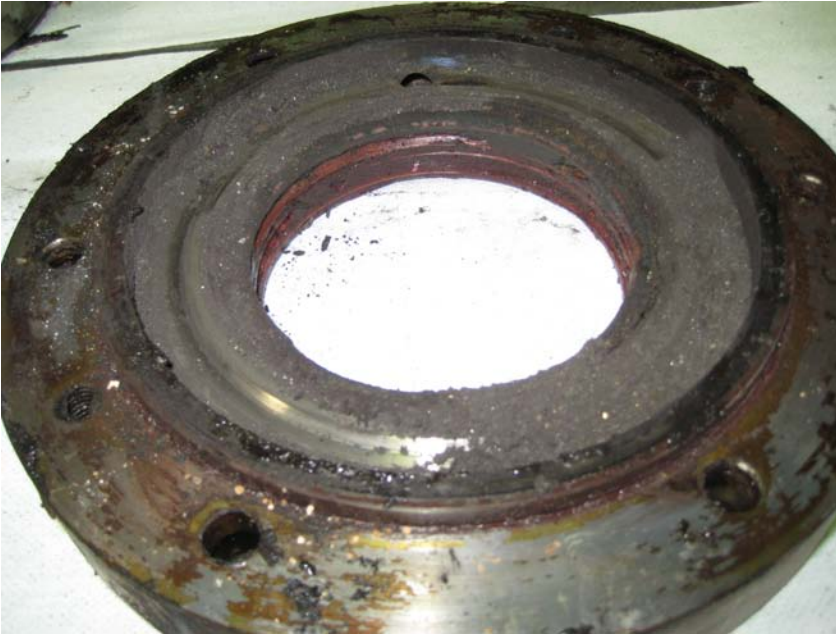
Figure 7: Photo of the bearing assembly end cap. Please note the location of the lubrication channels.

The bearing supplier's engineering consultants suggested the plant return to the old bearing style. In addition to the poor application of this new style of bearing, the lubrication was not entering the bearing due to the style of the cage (the old bearing was unshielded). (See Figure 7)

- The bearing housing and shaft were sent out to a machine shop to verify all measurements were within tolerances.
- The ball bearing was replaced with the old style bearing.
- The cylindrical roller bearings were also confirmed to be the correct bearing for this application.
