Radio Frequency Interference on Commtest VBx Series Data Collectors from Improperly Grounded Equipment

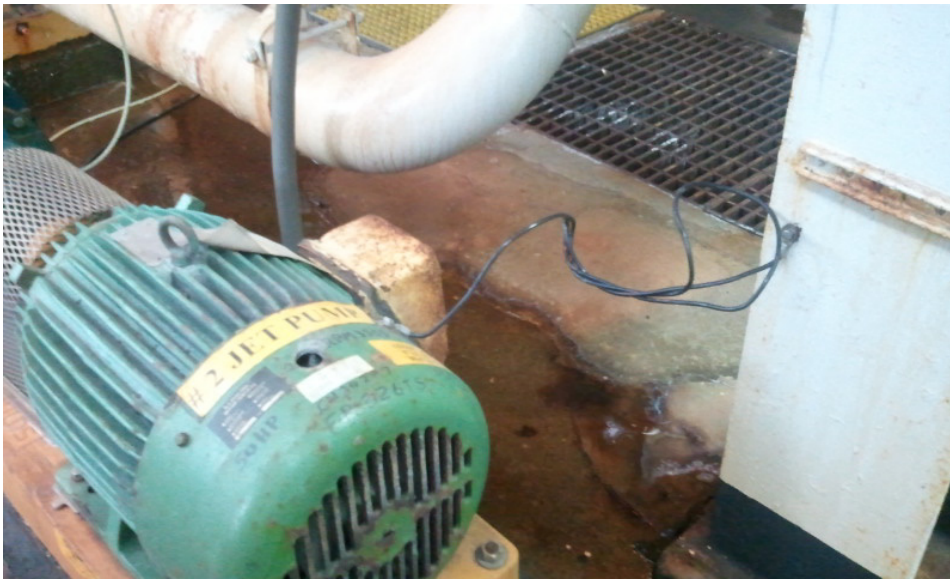
I attempted to take data with the VB7 on a pump that I knew would produce the symptom. I attached the transducer and tried to enter the speed. I had the same results as before. This made me think the cable was picking up stray radio frequencies and causing interference in the collector. I took the transducer off the motor and attempted to enter the speed. I still had the same issue. I walked away about 10 feet (3.3 meters) from the pump motor and tried to enter the speed. I had no problems. This piece of information led me to believe there was some sort of radio interference coming from the variable frequency drive.

Figure 1: Motor using auxiliary ground.

After the electrician installed the ground, I attempted to take measurements again on the motor. I entered the digits for the speed with no issues whatsoever. I moved the transducer around the motor in order to see if there was a place where I could cause the digit error. I could not replicate the problem. This solved my data collector problem.

My first idea was to consider the ground for the motor, as insufficient grounding can cause bearing defects by arcing across the bearing surfaces. I had not seen any vibration signatures of bearing fluting; however, I asked the site maintenance planner to have an electrician attach an auxiliary ground to the motor. When the electrician received the work request they told me this could not cause the issue. The electrician then installed the auxiliary ground.

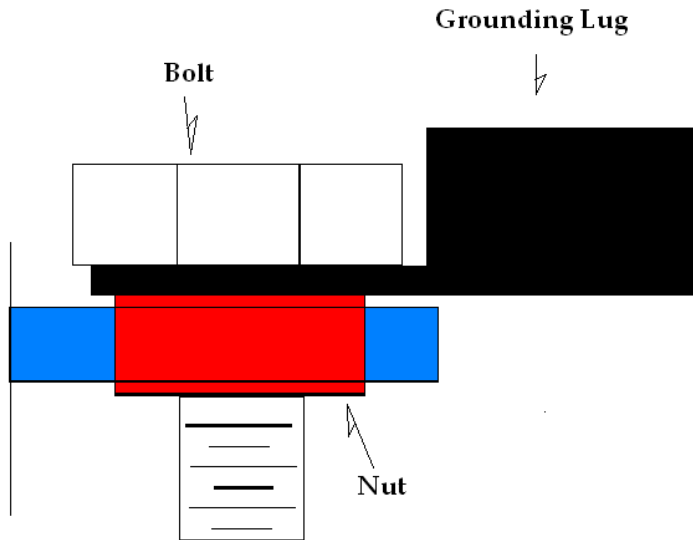
The second motor was inspected. The bolt holding the ground cable was too small for the bolt hole. The nut holding the ground cable was pulled inside the bolt hole to a point where the lug on the ground cable did not touch the housing. The motor was being grounded by the hex points of the nut.

Figure 2: Illustration of Grounding Lug on Second Motor.

Both of these motors, while operating normally, were improperly grounded. This lack of ground was not causing an immediate problem. However, this deficiency may cause two significant problems.

The most important issue is one of safety. The electrician who inspected the motors said these were traps waiting to catch someone. The environment in the evaporative plant is wet. Water and electricity are a fatal combination. Under the right conditions, someone working in the area could have been electrocuted. The ground is the last resort to divert electricity from passing through a person if a component in the motor short circuits.

The second issue that could have been caused is bearing fluting. This is caused by the rotor arcing across the bearing components from stray electrical fields. Bearings that are fluted may operate for a period but should be considered to be a failed bearing.

At this site, we now have a procedure if the VB7 data collector does not accept key presses correctly. We report the situation immediately to the planner. The planner writes a work request to have an auxiliary ground placed on the motor. This request is expedited as it could represent a major safety issue. The motor ground is then inspected at the next outage.

If a Commtest VBx data collector produces multiple key strokes while taking measurements on a motor, have the ground on the motor checked as soon as possible. This may at least save a piece of equipment and could possibly save a life.
